XRF Lead-Based Paint Survey Report

March 14, 2023

Conducted At:
Sanford Train Depot
106 Charlotte Avenue
Sanford, North Carolina 27330

Matrix Job # 230347

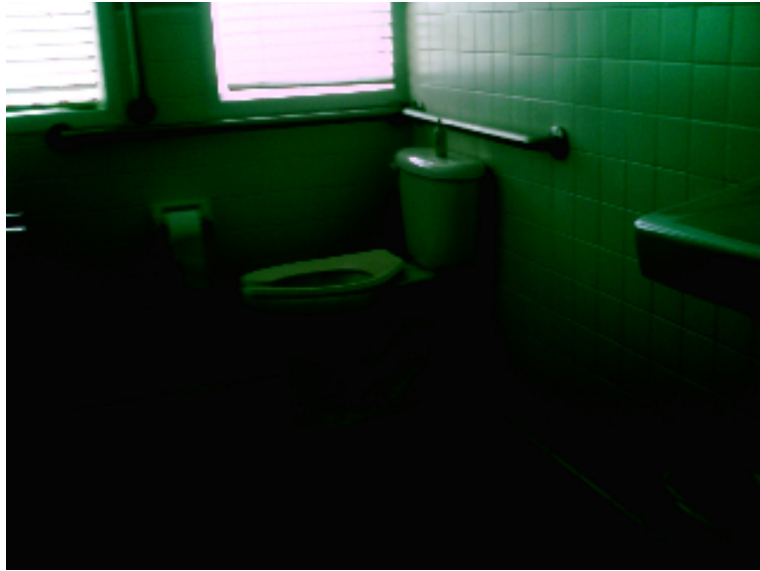
Reading #501

501 🚩	Positive	Off	Lower Wall	Ceramic	D	Intact	White	Women' Room		9.6 mg/cm ²	Action Level
502	Negative	Off	Floor	Ceramic	A	Intact	Blue	Women's Room		0.3 mg/cm ²	Action Level
503	Negative	Off	Door	Wood	C	Intact	White	Women' Room		0.0 mg/cm ²	Action Level
504	Negative	Off	Door Casing	Wood	C	Intact	White	Women's Room		0.0 mg/cm ²	Action Level
505	Negative	Off	Door Jamb	Wood	C	Intact	White	Women' Room		0.0 mg/cm ²	Action Level
506	Negative	Off	Window Casing	Wood	A	Intact	White	Women's Room		0.1 mg/cm ²	Action Level
507	Negative	Off	Window Sill	Wood	A	Intact	White	Women' Room		0.0 mg/cm ²	Action Level

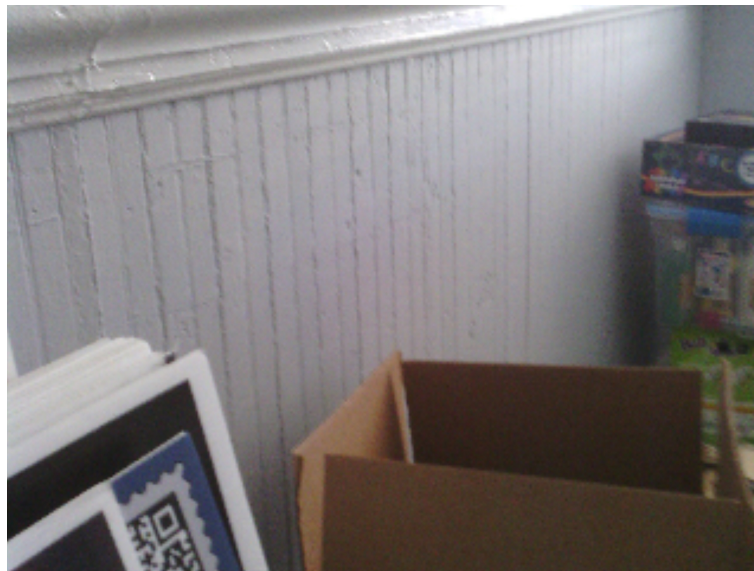
Reading #581

581	👁️ Positive	Off	Lower Wall	Wood	A	Intact	Gray	Storage		3.1 mg/cm ²	Action Level
582	Positive	Off	Chair Rail	Wood	A	Intact	White	Storage		2.0 mg/cm ²	Action Level
589	👁️ Positive	Off	Downspout	Metal	A Center	Intact	Green	Exterior		3.7 mg/cm ²	Action Level
591	👁️ Positive	Off	Soffit Support	Wood	A Center	Intact	Green	Exterior		8.3 mg/cm ²	Action Level
602		Off			Calibration					1.0 mg/cm ²	Action Level
603		Off			Calibration					1.1 mg/cm ²	Action Level

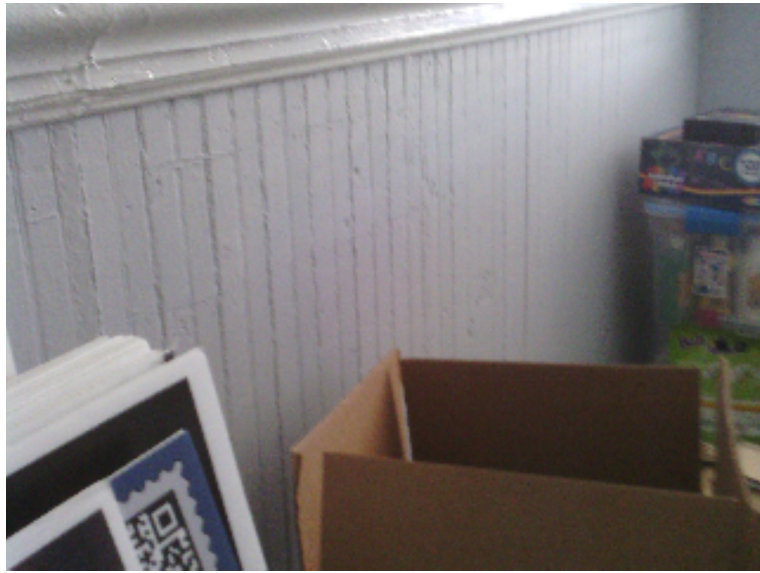
Reading #581

Read #	Result	RTA Present	COMPONENTS	SUBSTRATE	SIDE	CONDITION	Color	Floor	ROOM	Lead (mg/cm ²)	Mode
580	Positive	Off	Ceiling	Wood	C-Upper	Deteriorated	Tan	Storage		5.1 mg/cm ²	Action Level
581 🗿	Positive	Off	Lower Wall	Wood	A	Intact	Gray	Storage		3.1 mg/cm ²	Action Level
582	Positive	Off	Chair Rail	Wood	A	Intact	White	Storage		2.0 mg/cm ²	Action Level
583	Negative	Off	Siding	Brick	A	Intact	Red	Exterior		0.1 mg/cm ²	Action Level
584	Negative	Off	Door	Wood	A Left	Intact	Green	Exterior		0.1 mg/cm ²	Action Level
585	Negative	Off	Door Casing	Wood	A Left	Intact	Green	Exterior		0.0 mg/cm ²	Action Level
586	Negative	Off	Window Casing	Wood	A Right	Deteriorated	White	Exterior		0.0 mg/cm ²	Action Level
587	Negative	Off	Window Sill	Wood	A Right	Deteriorated	White	Exterior		0.1 mg/cm ²	Action Level
588	Negative	Off	Window Sill	Wood	A Right	Deteriorated	White	Exterior		0.4 mg/cm ²	Action Level
589 🗿	Positive	Off	Downspout	Metal	A Center	Intact	Green	Exterior		3.7 mg/cm ²	Action Level

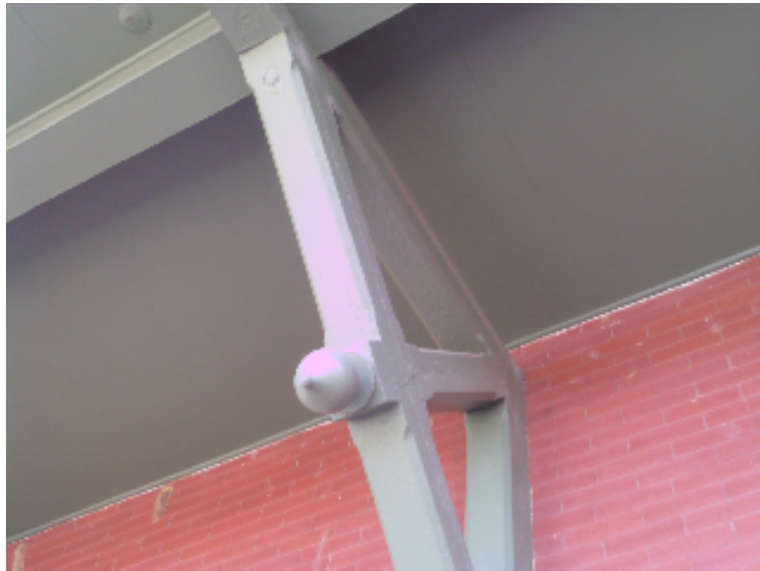
Reading #591

590	Negative	Off	Downspout	Metal	A Center	Intact	Green	Exterior		0.1 mg/cm ²	Action Level
591 🗿	Positive	Off	Soffit Support	Wood	A Center	Intact	Green	Exterior		8.3 mg/cm ²	Action Level
592	Negative	Off	Window Casing	Wood	B	Intact	White	Exterior		0.0 mg/cm ²	Action Level
593	Negative	Off	Window Sill	Wood	B	Intact	White	Exterior		0.0 mg/cm ²	Action Level
594	Negative	Off	Door	Wood	C Right	Intact	Green	Exterior		0.0 mg/cm ²	Action Level
595	Negative	Off	Door Casing	Wood	C Right	Intact	White	Exterior		0.0 mg/cm ²	Action Level
596	Negative	Off	Fence	Wood	C Center	Deteriorated	White	Exterior		0.0 mg/cm ²	Action Level
597	Negative	Off	Window Casing	Wood	C Left	Deteriorated	White	Exterior		0.1 mg/cm ²	Action Level
