Geotechnical Engineering Report
Pender County Law Enforcement Center

Burgaw, Pender County, North Carolina

ECS Project No. 22:31544

May 24, 2022

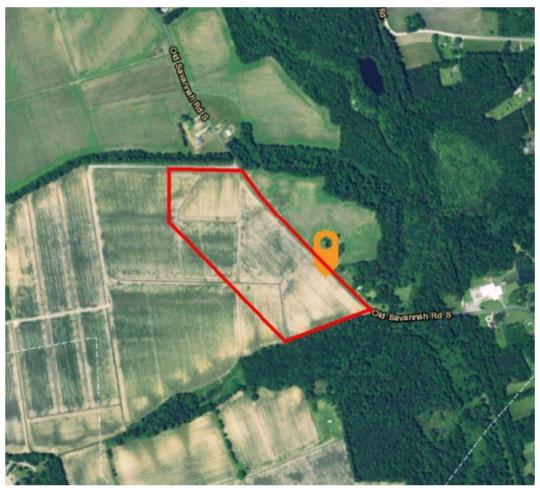
Figure 2.1.1 Site Location

The proposed site is located off of Old Savannah Road in Burgaw, North Carolina. The site is bounded on the northeast by Old Savannah Road, on the north and southeast by wooded land, and on the west by agricultural fields. Figure 2.1.1 below shows an image of where the site is located.

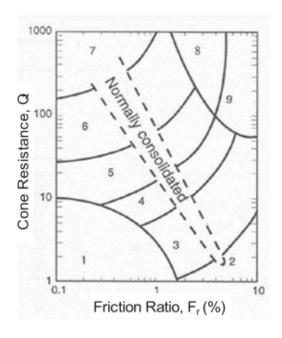
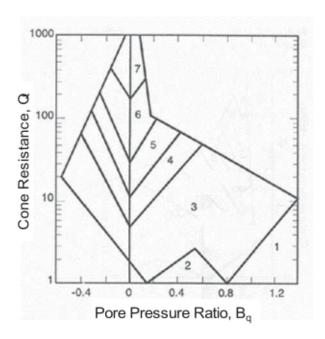
REFERENCE NOTES FOR CONE PENETRATION TEST (CPT) SOUNDINGS

In the CPT sounding procedure (ASTM-D-5778), an electronically instrumented cone penetrometer is hydraulically advanced through soil to measure point resistance (qc), pore water pressure (u2), and sleeve friction (fs). These values are recorded continuously as the cone is pushed to the desired depth. CPT data is corrected for depth and used to estimate soil classifications and intrinsic soil parameters such as angle of internal friction, preconsolidation pressure, and undrained shear strength. The graphs below represent one of the accepted methods of CPT soil behavior classification (Robertson, 1990).

- 2. Organic Soils-Peats
- 3. Clays; Clay to Silty Clay
- 4. Clayey Silt to Silty Clay
- Silty Sand to Sandy Silt

6. Clean Sands to Silty Sands

- 7. Gravelly Sand to Sand
- 8. Very Stiff Sand to Clayey Sand
- 9. Very Stiff Fine Grained

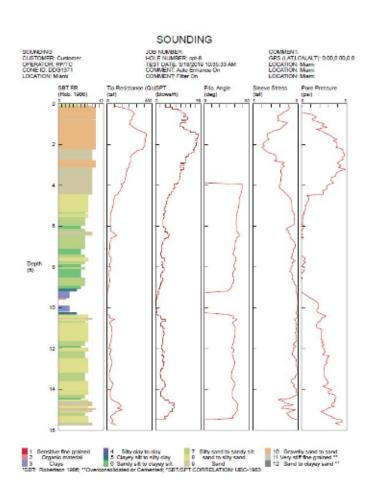
SUBSURFACE EXPLORATION PROCEDURE: CONE PENETRATION TESTING (CPT) ASTM D 5778

In the CPT sounding procedure, an electronically instrumented cone penetrometer is hydraulically advanced through soil to measure point resistance (qc), pore water pressure (U2), and sleeve friction (fs). These values are recorded continuously as the cone is pushed to the desired depth. CPT data is corrected for depth and used to estimate soil classifications and intrinsic soil parameters such as angle of internal friction, pre-consolidation pressure, and undrained shear strength.

CPT Procedure:

- Involves the direct push of an electronically instrumented cone penetrometer* through the soil
- Values are recorded continuously
- CPT data is corrected and correlated to soil parameters

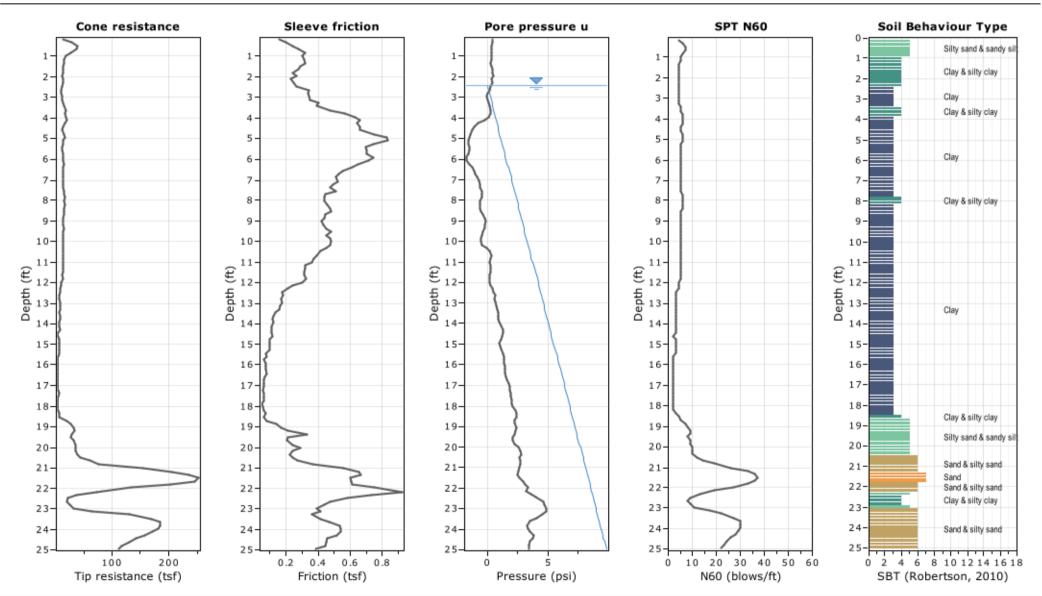
Project: Pender County Law Enforcement Center Location: Burgaw, Pender County, North Carolina CPT: S-1

Total depth: 24.93 ft, Date: 4/6/2022

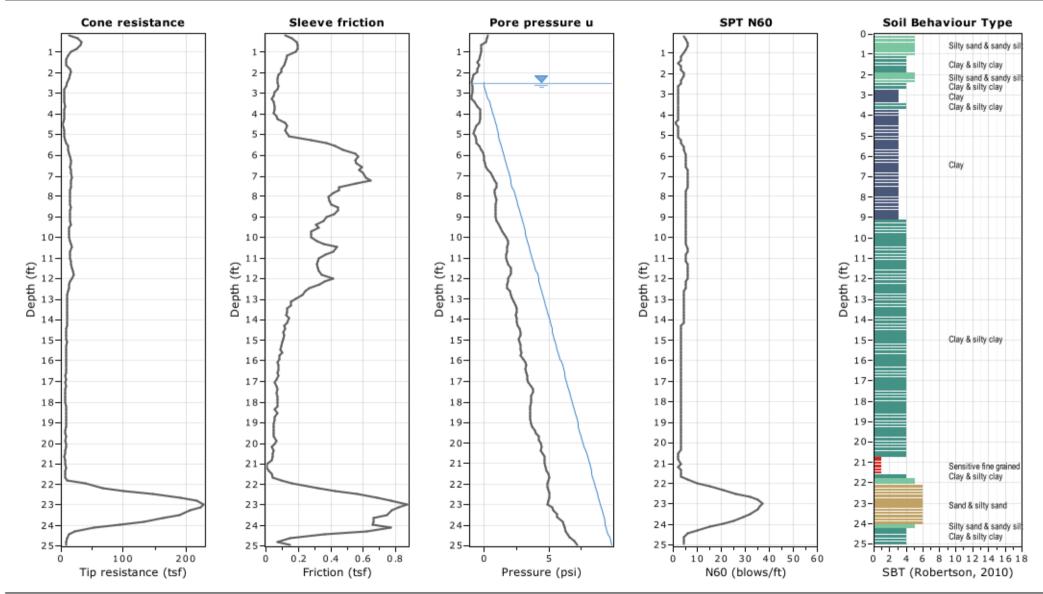
CPT: S-2

Total depth: 24.93 ft, Date: 4/6/2022

- Due to the very soft clays encountered in the soundings S-2, S-6, S-11, and S-12, undercutting
 approximately 4 to 5 feet in the vicinity of the soundings should be anticipated prior to
 construction of foundations and placement of Structural Fill.

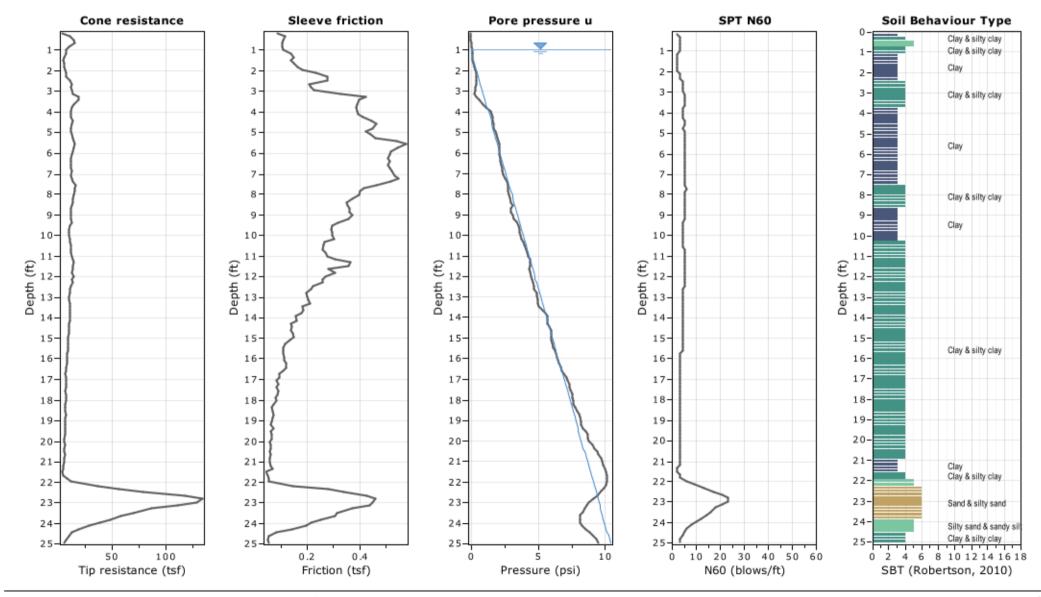
CPT: S-3

Total depth: 24.93 ft, Date: 4/6/2022

- Due to the near surface very soft clays encountered in the soundings S-3 and S-7, undercutting approximately 1.5 feet in the vicinity of the soundings should be anticipated prior to construction of foundations and placement of Structural Fill.

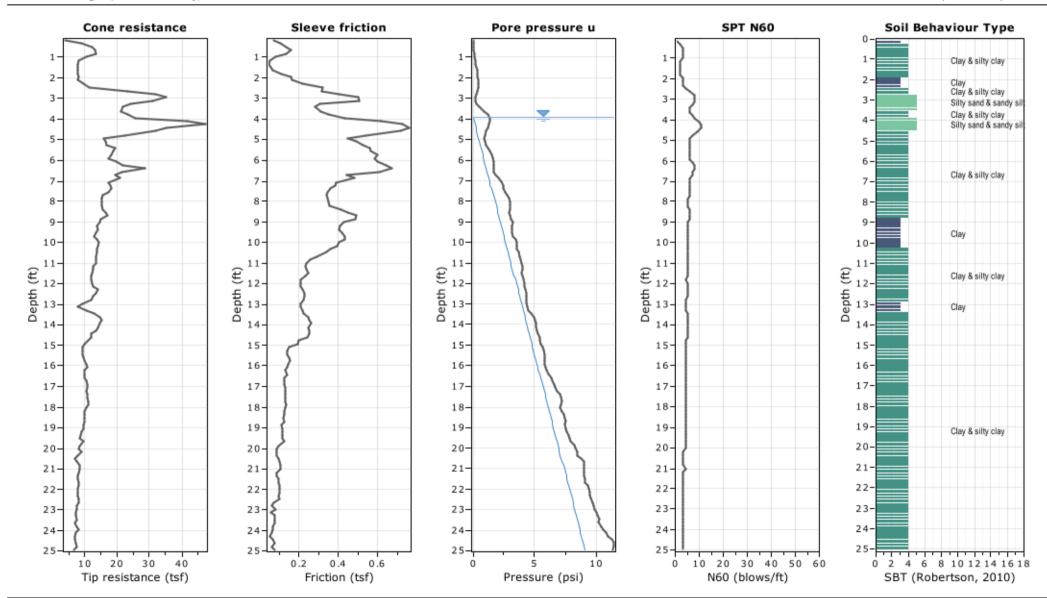
Project: Pender County Law Enforcement Center Location: Burgaw, Pender County, North Carolina CPT: S-4

Total depth: 24.93 ft, Date: 4/6/2022

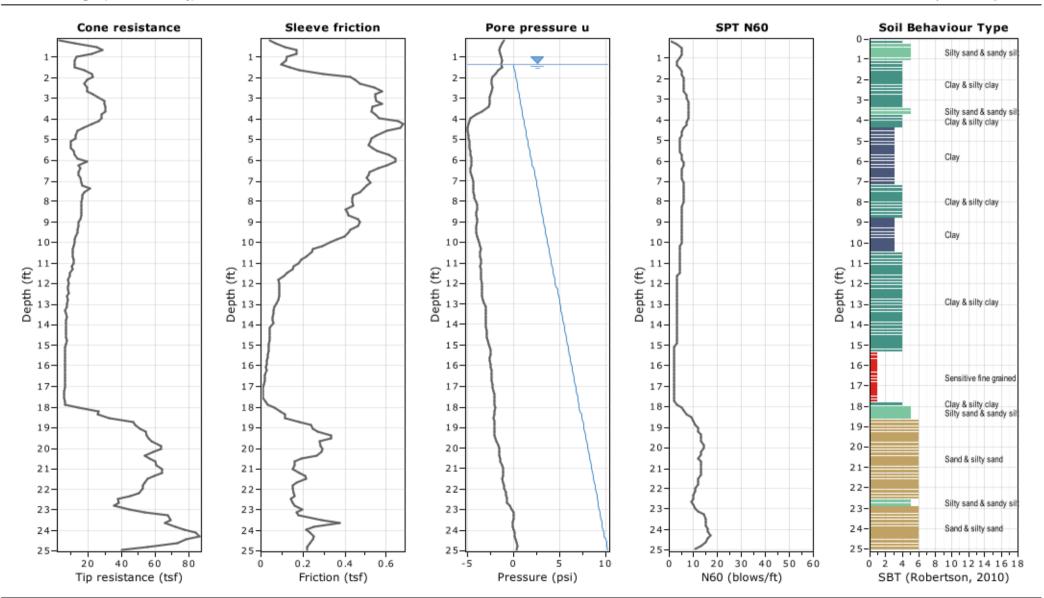
Project: Pender County Law Enforcement Center Location: Burgaw, Pender County, North Carolina CPT: S-5

Total depth: 24.93 ft, Date: 4/6/2022

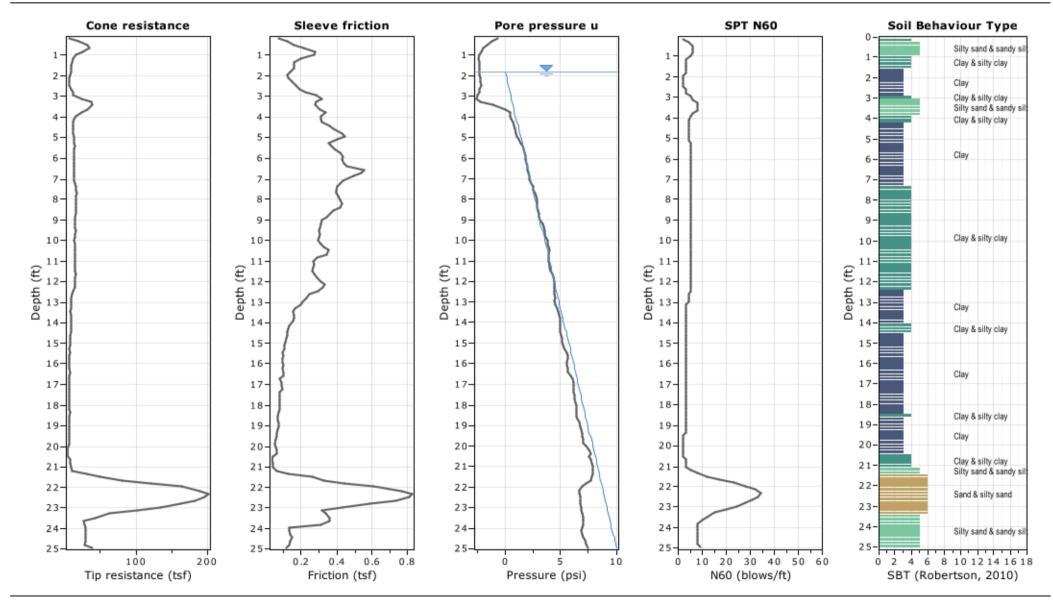
CPT: S-7

Total depth: 24.93 ft, Date: 4/6/2022 Cone Operator: Cory Robison

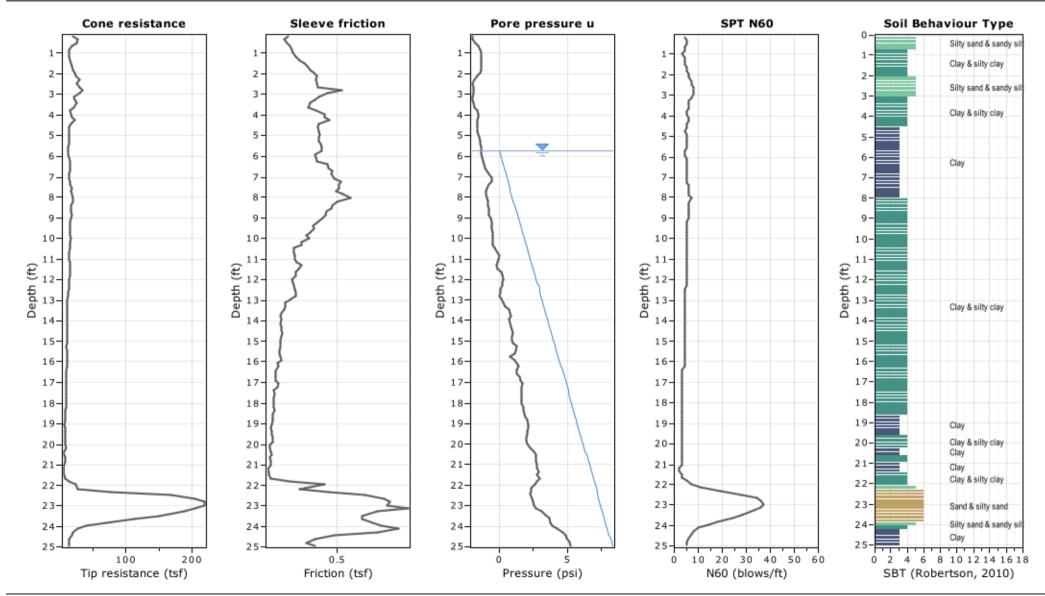
Project: Pender County Law Enforcement Center Location: Burgaw, Pender County, North Carolina CPT: S-8

Total depth: 24.93 ft, Date: 4/6/2022

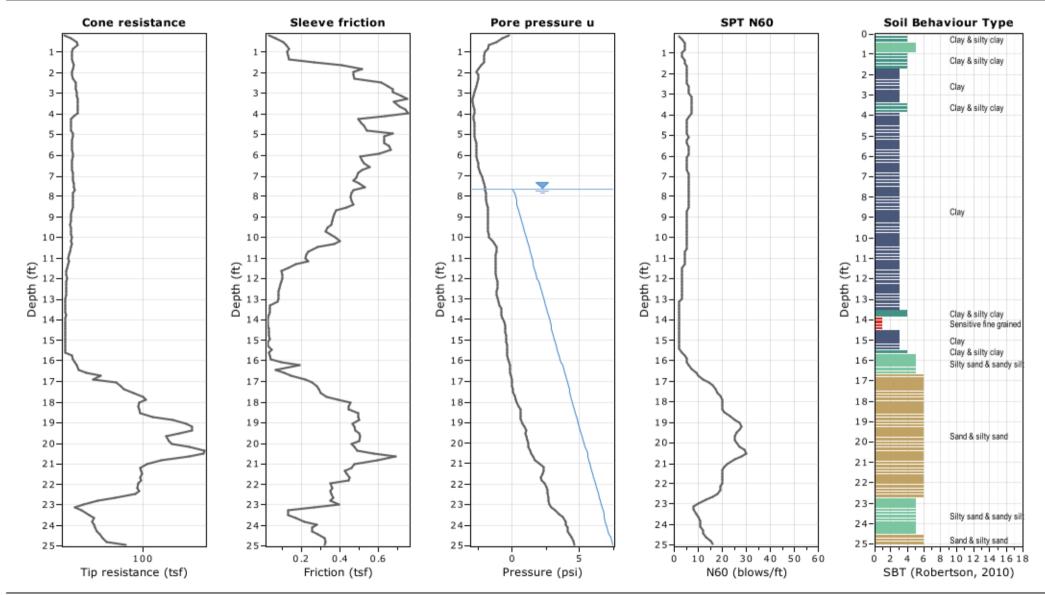
Project: Pender County Law Enforcement Center Location: Burgaw, Pender County, North Carolina CPT: S-10

Total depth: 24.93 ft, Date: 4/6/2022

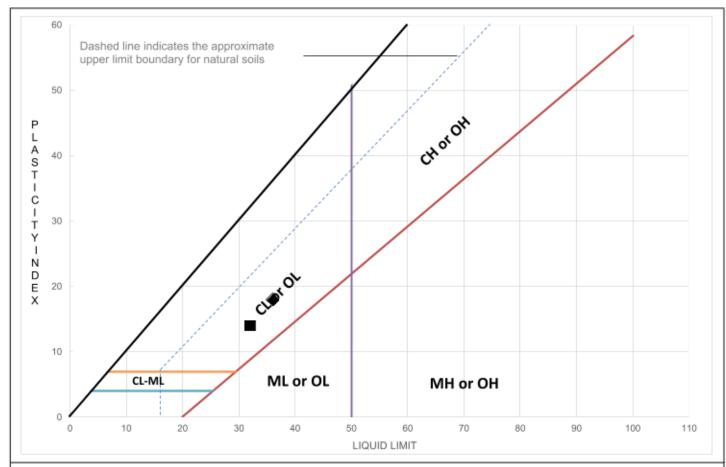
LIQUID AND PLASTIC LIMITS TEST REPORT

TEST RESULTS (ASTM D4318-10 (SINGLE POINT TEST))

Sample Location	Sample Number	Sample Depth (ft)	LL	PL	PI	%<#40	%<#200	AASHTO	uscs	Material Description
K-08	S-1	2-3	32	18	14					gray/red
K-10	S-1	3-4	36	18	18					gray/orange/red
